# Manhole Inspection Summary

Manhole # S29EE1001MH

Insp Date: **12/15/06 1:31 PM**

**Location** Address: **3828 TUDOR ARMS AVE**

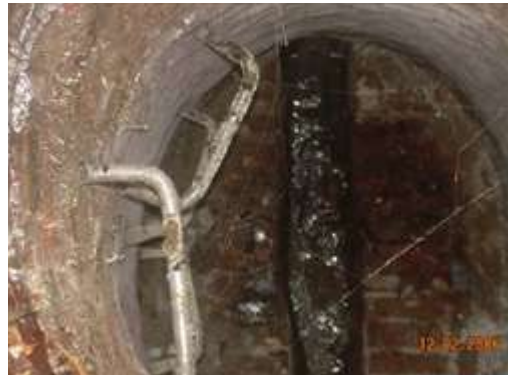
Top View

Bench debris.

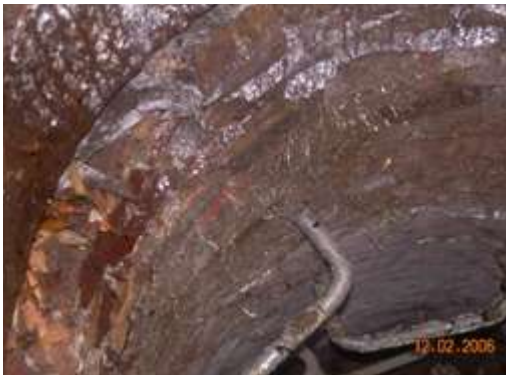
Defect

Frame offset. Frame leaks. Adjustment deterioration, root intrusion and infiltration. Corbel root intrusion and infiltration.

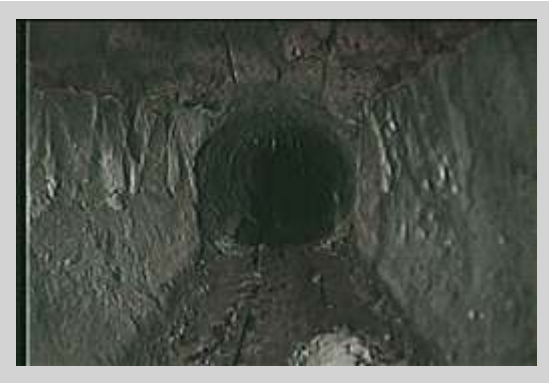
### 8 in. Circular Gravity Sewer Pipe Out @ 12 O'Clock

Infiltration: **Evidence** Pipe Seal Cond: **Cracked**

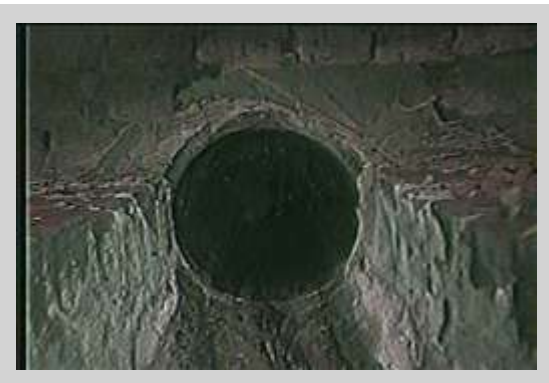
### 8 in. Circular Gravity Sewer Pipe In @ 6 O'Clock

Infiltration: **Evidence** Pipe Seal Cond: **Unknown**
